# Home Inspection Report

**Inspector: Paul Myette**

## Inspection Report Table of Contents

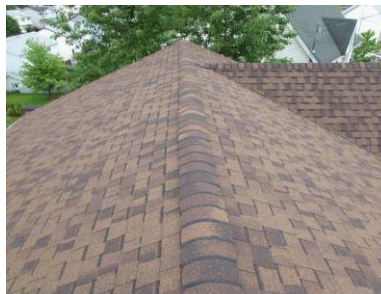
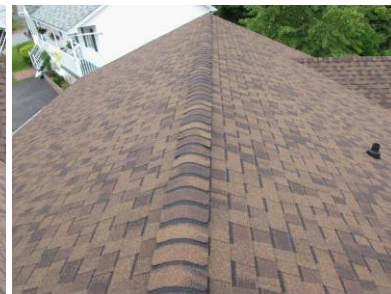
<i>Style:</i>	Gable.
<i>Inspection Method:</i>	Walked on roof.
<i>Roof Covering:</i>	Asphalt shingle.
<i>Roofing Shingle Layers:</i>	One.
<i>Age Of Roof:</i>	1 to 5 years.
<i>Condition Of Roof:</i>	General condition of roof covering appears serviceable with normal signs of weathering and aging. Regular maintenance and inspections are advised.

**Roof covering appears serviceable**

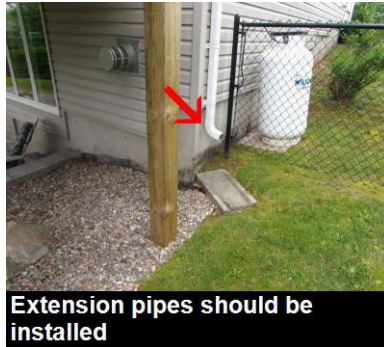
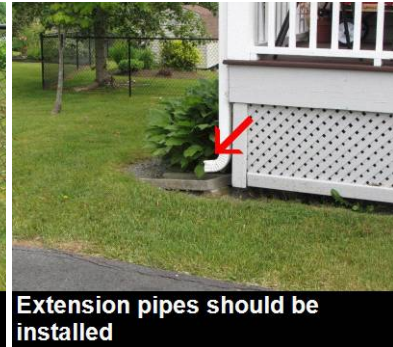
Downspouts discharge water too close to dwelling, extension pipes should be installed to discharge the water at least 6 feet from the foundation.

Most basement water infiltration problems can be attributed, at least in part, to poor exterior drainage. This includes poor grading and inadequate downspouts. Unless you attend to gutters, downspouts, grading and so on, you increase the likelihood of water penetration into below grade areas.

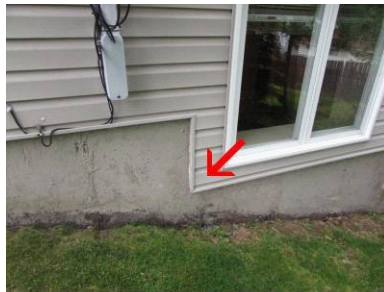
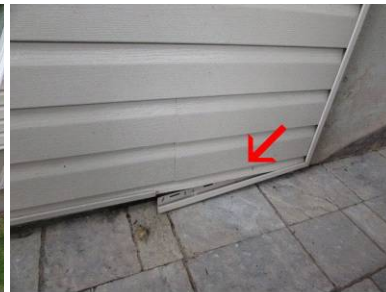
Loose section of siding noted in the step down area on the right side of the dwelling and the bottom edge of the siding along the back of the dwelling.

**Loose section of siding noted**

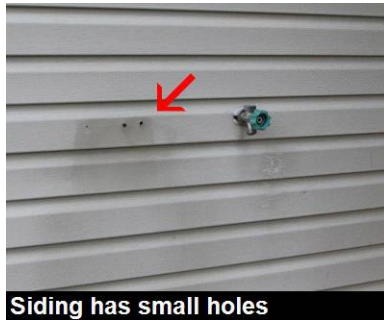
Siding has small holes around the frost proof hose faucets. These holes should be sealed with caulking to prevent water penetration.

**Siding has small holes**

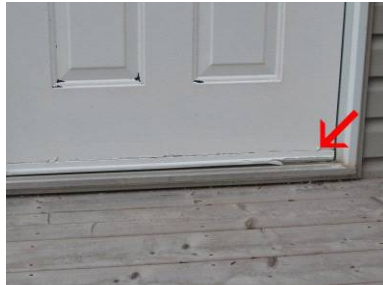
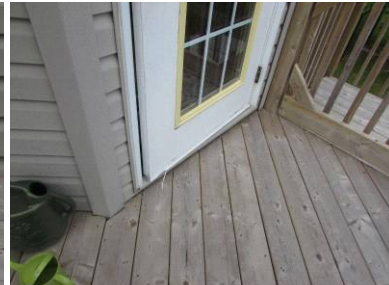
Recommend upgrading door sweep on the back door and the basement walkout door.  
Minor paint peeling noted.

**Recommend upgrading door sweep**

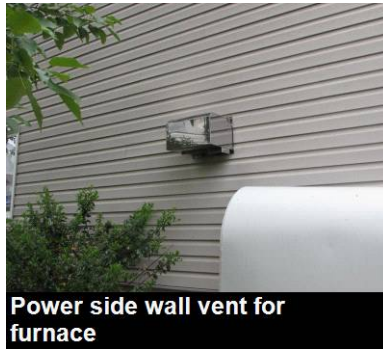
Power side wall vent for furnace, & Standard side wall vent for the propane fireplace.

**Power side wall vent for furnace**

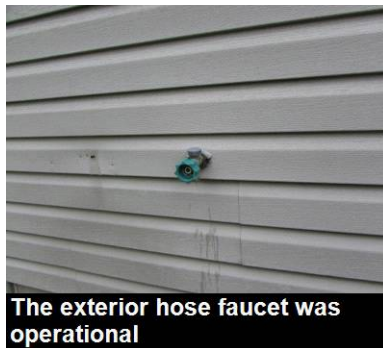
**The exterior hose faucet was operational**

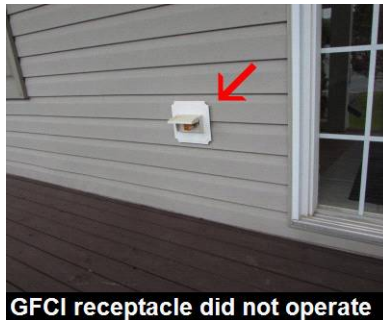
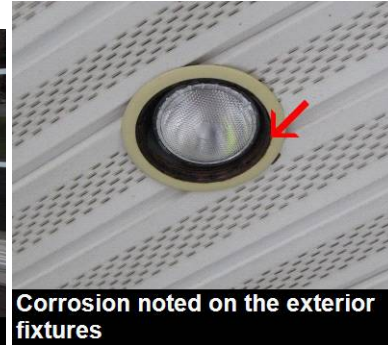
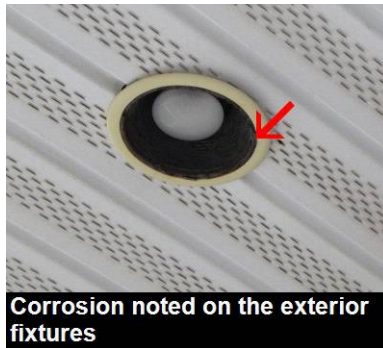
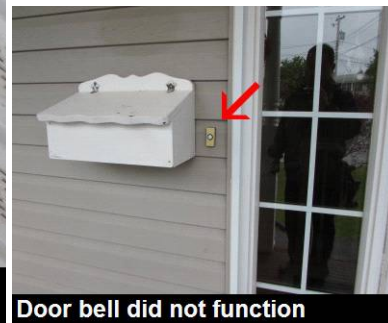
Ground fault circuit interrupter (GFCI receptacle) did not operate when tested mechanically, receptacle did not trip: replace or repair GFCI receptacle located at, front of dwelling  
Corrosion noted on the exterior light fixtures on the front of the dwelling.  
Door bell on the front of the dwelling did not function at the time of the inspection.

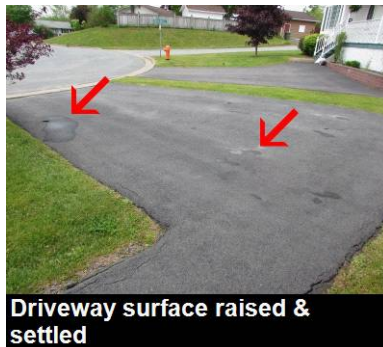
Driveway cracks noted are typical.  
Driveway surface raised & settled.

**Driveway surface raised & settled**

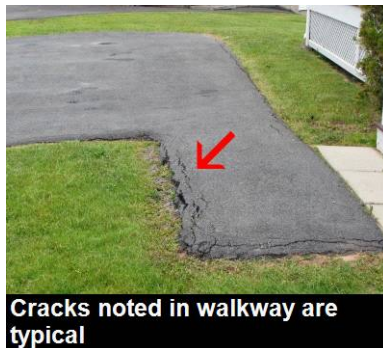
**Cracks noted in walkway are typical**

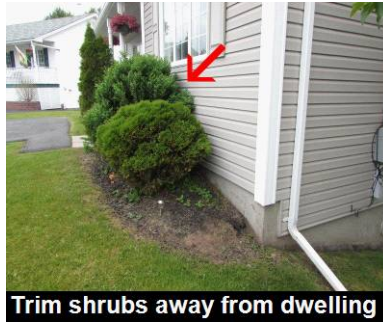
**Trim shrubs away from dwelling**

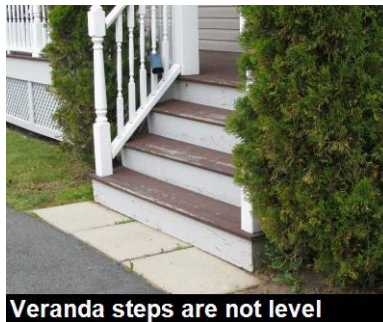
Settlement noted; veranda steps are not level  
Deterioration noted on veranda surface.

**Veranda steps are not level**

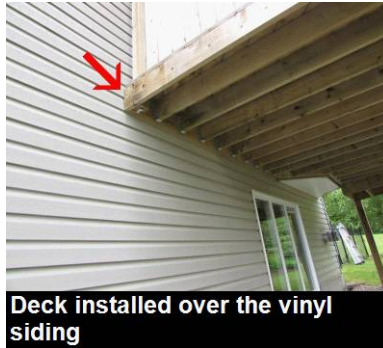
The deck appears to be installed directly over the vinyl siding, no flashing was visible at the time of the inspection. All decks should be properly flashed where they are attached to the dwelling to prevent water damage in this area. The area where the deck is attached to the dwelling should be checked on a regular basis.  
Deck handrail requires the installation of a metal bracket to secure the handrail to the dwelling  
Deck stairs appear serviceable.

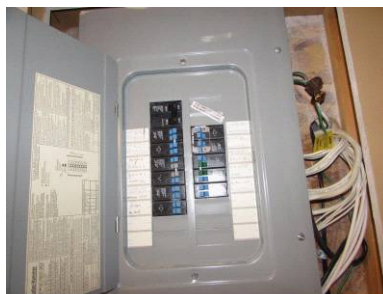
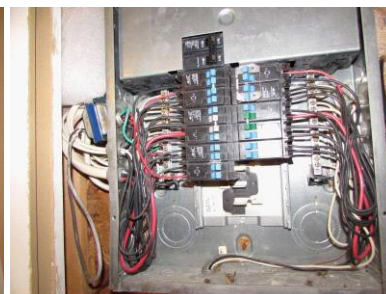
*Condition Of Main Electrical Panel:* Main electrical panel appears serviceable.

**Main electrical panel appears serviceable**

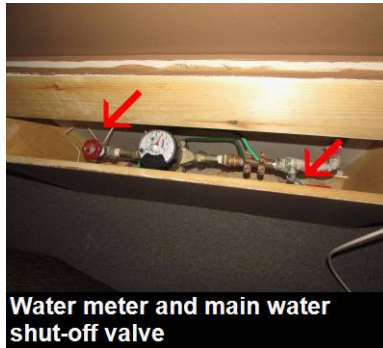
Water meter and main water shut-off valve are located along the front wall in the family Room.

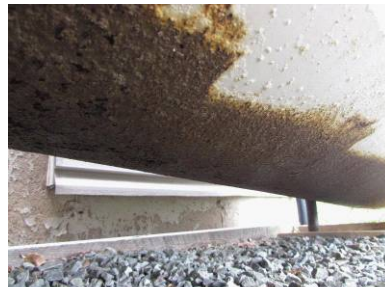
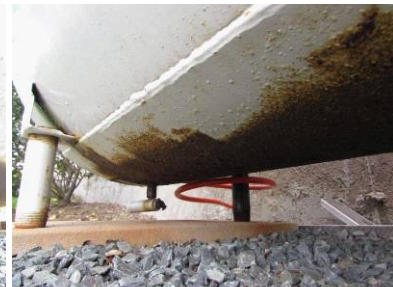
Oil tank inspection showed rust on the bottom of the oil tank; no signs of any oil leaks were observed at the time of the inspection

**Rust noted on the bottom of the oil tank**

**Recommend oil tank be further evaluated by a professional heating contractor.**

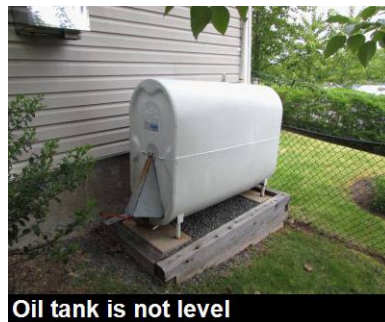
Oil tank is not level, monitor this area. The oil tank may require leveling.

**Oil tank is not level**

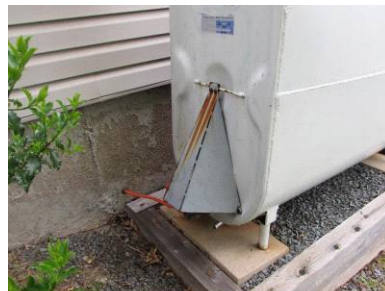
Oil line & valve appear serviceable.  
There is a loop in the oil line.  
A protective cover is installed over the oil line and valve.

**Oil line & valve appear serviceable.**

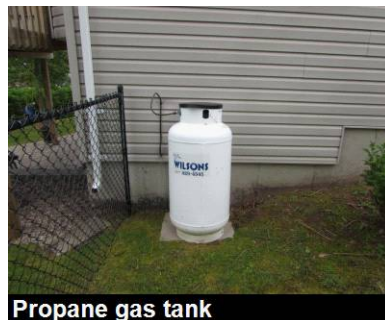
Propane gas tank is located next to dwelling.

**Propane gas tank**

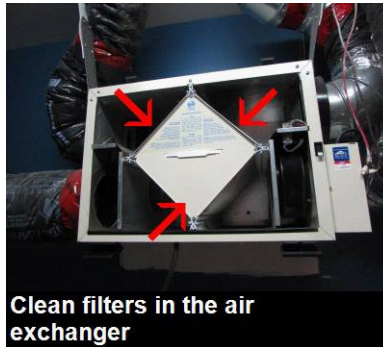
**Clean filters in the air exchanger**

Recommend filters in the air exchanger and exterior intake air vent be cleaned every 6 months or as directed in the service manual.

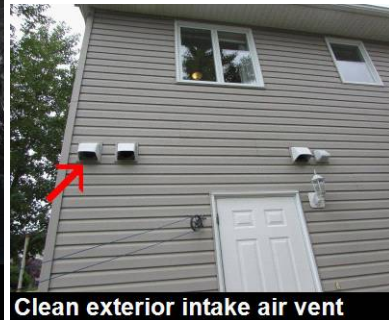
**Clean exterior intake air vent**

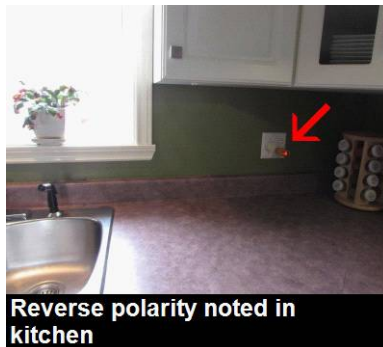
<i>Type Of Kitchen Ventilation:</i>	External.
<i>Condition Of Ventilation;</i>	Range hood operational.
<i>Garburators:</i>	Garburator appears serviceable.
<i>Switches, Fixtures, Receptacles:</i>	Reverse polarity noted in kitchen receptacle to the right of the kitchen sink.

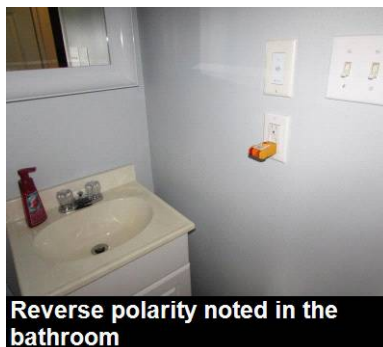
<i>Condition Of Bathroom Ventilation:</i>	Bathroom ventilation appears serviceable There is a control switch installed in the bathroom for the air exchanger.
<i>Condition Of Bathroom Windows:</i>	Bathroom window appears serviceable.
<i>Condition Of Bathroom Doors:</i>	Bathroom door appears serviceable.
<i>Condition Of Bathroom Switches &amp; Fixtures:</i>	Bathroom switches & fixtures appear serviceable.
<i>Condition Of Bathroom Gfci Receptacles:</i>	Reverse polarity noted in the basement bathroom receptacle.

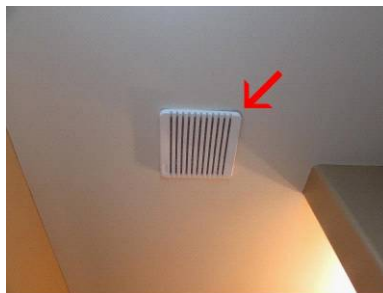
**Bathroom ventilation fan  
requires cleaning**

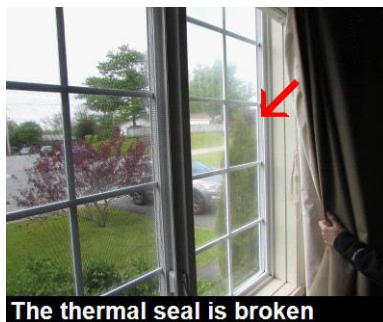
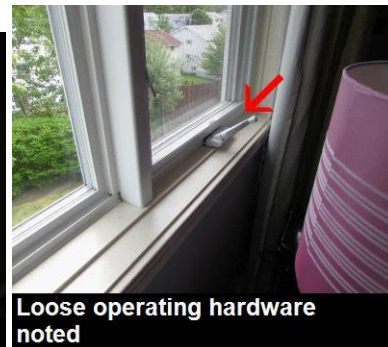
*Type:* Vinyl, Casement.  
*Condition:* The thermal seal is broken in the main floor front bedroom window. Although the window is keeping the elements out, it has a clouded appearance. This condition will worsen.  
Loose operating hardware noted in the main level back bedroom window.  
Windows as a grouping are generally operational.

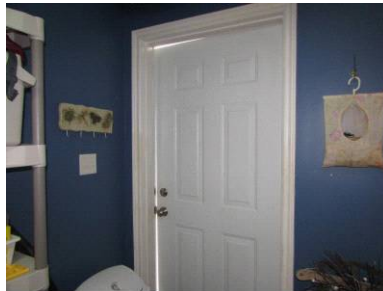
The utility room door binds, adjustments are required.  
Closet doors in the basement bind on the floor.  
General condition of interior doors appears serviceable.

**The utility room door binds**

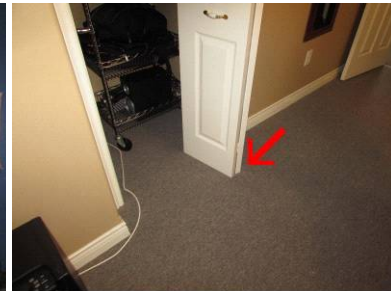
**Closet doors bind on the floor**

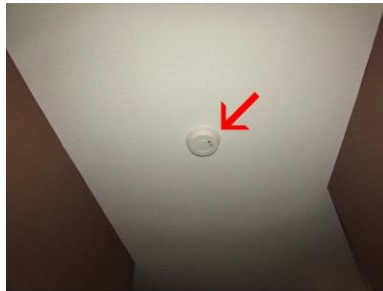
All smoke detectors are electric, as a safety precaution battery smoke detectors should be installed as backup  
Smoke detectors are old. The life expectancy of a smoke detectors is 10 years. Suggest replacement of all smoke detectors.

**All smoke detectors are electric**

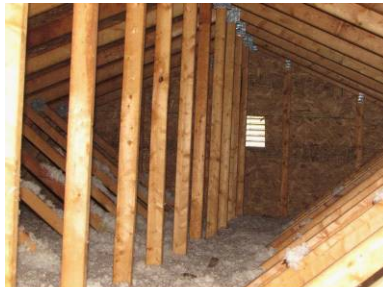
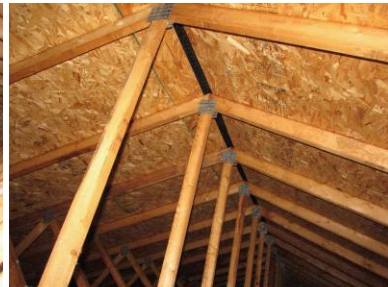
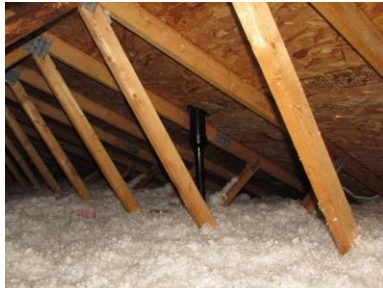
<i># Of Attics Or Crawlspaces:</i>	One.
<i>Access Location:</i>	Access to the attic is located in the, hallway.
<i>Access By:</i>	Access to the attic provided by; ceiling hatch.
<i>Accessible:</i>	Attic accessible appears serviceable.
<i>Attic Size:</i>	Full size attic.
<i>Structure:</i>	A truss system is installed in the attic cavity; trusses are used to support the roof decking and transmit the roof load to the exterior walls.
<i>Condition:</i>	Appears serviceable, The general condition of the truss and roof decking system appears to be in satisfactory condition.

**Truss and roof decking system**

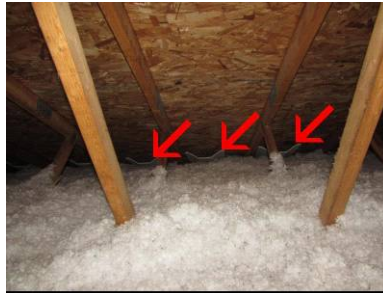
<i>Ventilation:</i>	There appears to be adequate attic ventilation installed. Styrofoam true vent air channels are provided.
---------------------	--

**Styrofoam true vent air channels**

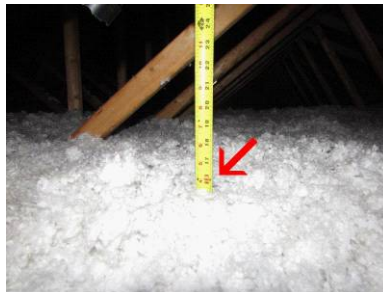
15-16 inches of insulation.

**15-16 inches of insulation.**

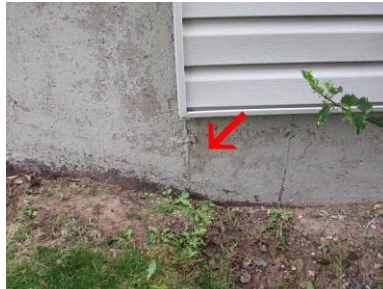
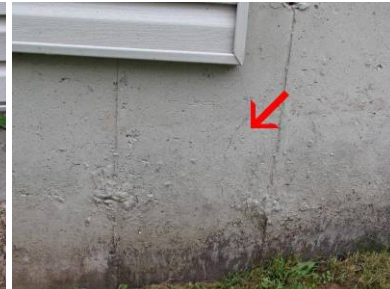
There are hairline cracks in the side foundation walls. These cracks should be filled with a silicon base, flexible-sealing compound, which should stop water/moisture from penetrating. At the time of the inspection no signs of water or water penetration were found.

**Hairline crack in the side foundation wall**
